NPIC/R-362/63 December 1963

PHOTOGRAPHIC INTERPRETATION REPORT

# SA-2 SAM SITES WITH ASSOCIATED LARGE REVETMENTS, **USSR**

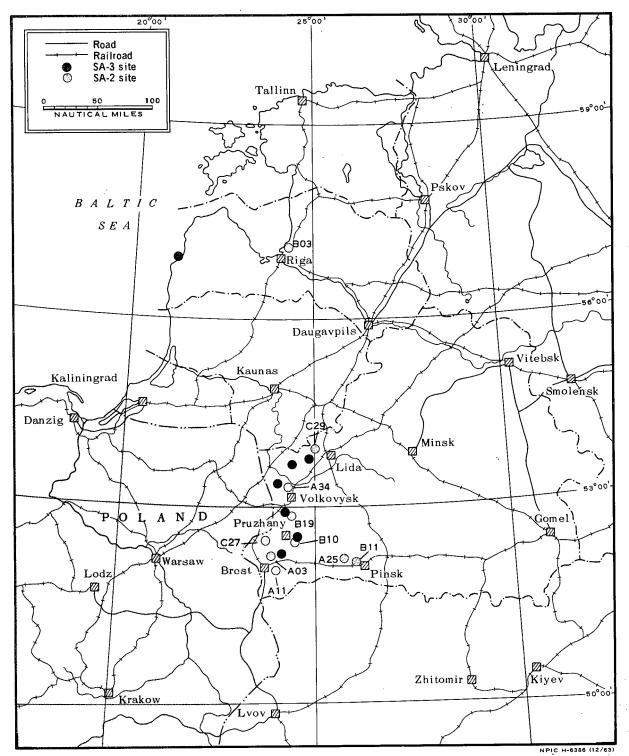
FIGURE 1. SA-2 SAM SITES WITH LARGE REVETMENTS, USSR.

A total of tenSA-2SAM sites with associated large revetments have been identified in the USSR. Nine of these sites are located in the Soviet-Polish border area, and the tenth site is located at Riga (Figure 1).

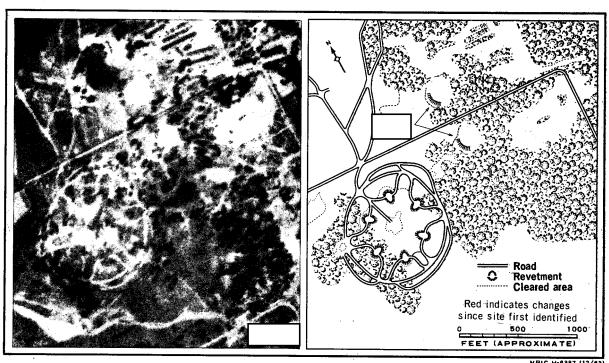
FIGURE 2. PINSK MRBM COMPLEX SAM SITE B11-2.

Ν	NPIC/R-362/63		25X1
25X1D 5X1D 5X1D 5X1D 5 X1D 1	This site,	both areas were under construction in  but neither had been started in  Site A25-2 was identified or  tography of and appeared complete.  The site support area contained the normal complement of buildings at that time and no changes had taken place by  The nearest SA-2 SAM site with similar large revetments is Pinsk B11-2, located 17 nm east. The nearest SA-3 SAM site is Pruzhany MRBM Complex B10A-3, located 46 nm west northwest.	25X1 25X1 25X1 25X1D
5X1	serving either of the revetments. Both were constructed between		_
25X1D 25X1D 25X1D 25X1 25X1	and no change had taken place in either reverment by  When Pinsk MRBM SAM Site B11-2 was identified on photography of it appeared complete. Pinsk Army Barracks probably provides support facilities for the site inasmuch as there are no typical site support buildings. A clearing southeast of the large reverments has been expanded about 30 percent since 25X1D  The nearest SA-2 SAM site with similar large revetments is Pinsk A25-2, located 17 him west; the nearest SA-3 SAM site, Pruzhany B10A-3, is 55 nm northwest.  Pinsk MRBM Complex SAM Site A25-2	This site,	25X1D 25X1

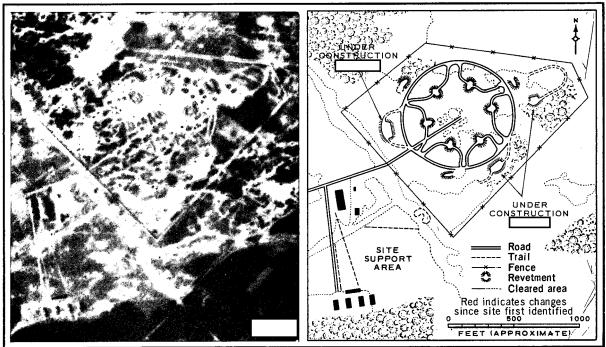
25X1D FIGURE 4. BREST SAM SITE A11-2.

NPIC/R-362/63		25X1
25X1D	This site, is located at	25X1D ments first appeared on photography of The site support area was complete when the site was identified and had not changed by	25X1D
25X1 25X1D	52-13-40N 23-49-30E, 9 nm north-northeast of Brest.  Two large revetments adjacent to this site were identified on photography of One revetment, 90 by 70 feet, is 625	The nearest SA-2 site with similar large revetments is Brest A03-2, located 17 nm south. Pruzhany MRBM Complex SAM Site B10A-3 is located 27 nm east.	
25X1D	feet northeast of the center of the site, and the other,t, is 580 feet northeast of the center of the site. Both revetments are rectan-	Pruzhany MRBM Complex SAM Site B10-2	25X1D
25X1	gular and drive-through (Figure 5). When Brest SAM Site A03-2 was identified	This site is located at 52-30-00N 24-30-15E, 13 nm east-southeast of	
25X1D	on photography of , it appeared complete. The large revetments were	Pruzhany MRBM Complex.  Two large revetted circular areas were

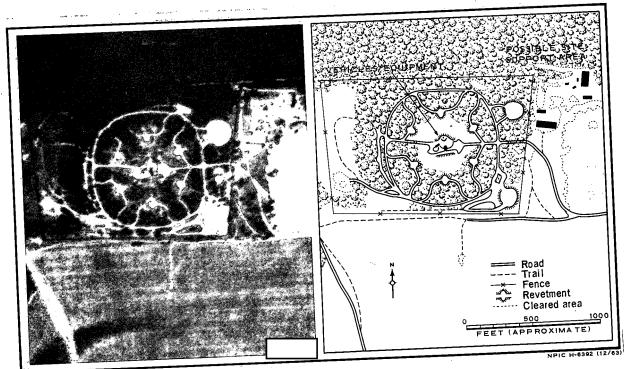
25X1D FIGURE 7. PRUZHANY SAM SITE B10-2.

25X1D 25X1 25X1C	One revetment, 90 by 83 leet, 18 10	typical of those in site support areas, the absence of any others nearby indicates their possible support role.  The nearest SA-2 site with similar large revetments is Volkovysk B19-2, located 25 nm north. Collocated SA-3 site B10A-3 is 2.3 nm north.	
	cated 550 feet south-southwest of the center of the site and the other, 90 by 75 feet, is located 550 feet north-northeast of the center of the site. Both are drive-through and are served by road from the site perimeter service road (Figure 6).  Pruzhany SAM Site C27-2 was probably	This site, is located at 52-55-35N 24-25-20E, 15 nm south of Volkovysk.  Two large circular revetments adjacent to	25X1D 25X1
25X1	complete when identified on photog-	the east side of the site were identified on photography of Both revet-	25X1
	raphy of but the large revet-	. 4 -	25X1

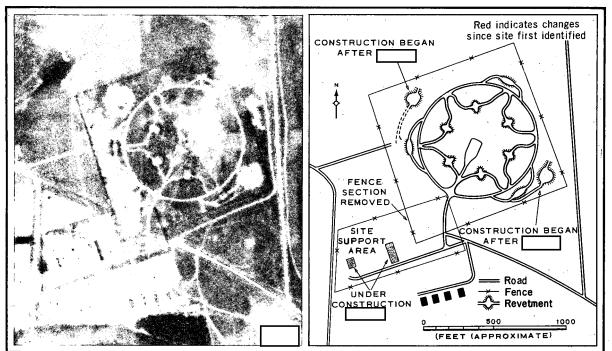
25X1D FIGURE 9. VOLKOVYSK SAM SITE A34-2. 25X1D 25X1D

25)	X1D
	ments are approximately 170 feet in diameter	Volkovysk SAM Site A34-2 was identified on	
	and the centers of both are about 650 feet from	photography of at which	
	the center of the site. The revetments are		25X1
<b>1</b>	drive-through and are served by road from the	large revetments were not present. The site	
	perimeter service road of the site (Figure 8).	support area was under construction between	25>
	No change had taken place in either revetment	when it appeared	207
_ 25X1D	by	complete, having the normal complement of	
25X1		buildings for site support.	
_	Volkovysk SAM Site B19-2 was complete	The nearest SA-2 site with similar large	
<b>_</b> 25X1D	when identified on photography of	revetments is Volkovysk B19-2, located 23 nm	
	The large revetments were not	south. Collocated SA-3 site A34A-3 is approxi-	
	present at that time but first appeared in early	mately 2,000 feet northwest.	
_25X1D	stages of construction in	matery 2,000 feet normwest.

1	to either site can be identified.	
	Volkovysk SAM Site A34-2	Lida MRBM Complex SAM Site C29-2 was	25X1
25X1D		complete when identified on photog-	25>
20,(12	This site, , is located at	raphy of but the large revet-	207
	53-18-00N 24-22-20E, 9 nm north-northwest of	ments first appeared under construction in	25>
1	Volkovysk and immediately west of Ros Airfield.	The site support area was	,
	Two large revetments adjacent to this site	partly completed when the site was identified.	
25X1D	were identified on photography of	Since then, 7 buildings have been added: 5 prob-	
	(Figure 9). One revetment, 85 by 65	able barracks, 1 large building (155 by 60 feet)	
25X1	feet, is located 535 feet southeast of the center	and 1 smaller building (50 by 30 feet). These 7	25>
	of the site, and the other, 70 by 60 feet, is lo-	buildings were under construction on	
	cated 550 feet northwest of the center of the	photography.

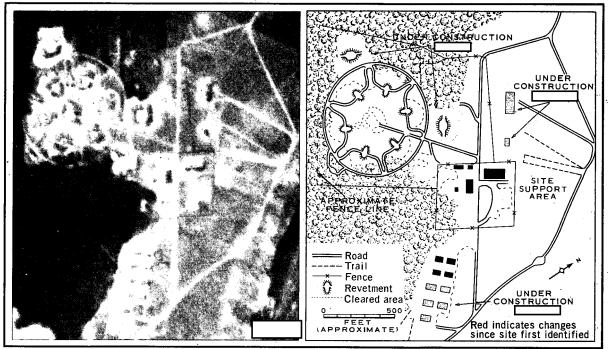
FIGURE 10. LIDA MRBM COMPLEX SAM SITE C29-2.

The site support area appeared complete		
25X1D	when the site was identified; however, in	Lida MRBM Complex SAM Site C29-2	
25X1D	two additional buildings were noted. Sub-	The CANA de la la	25>
	sequent photography revealed that what had	This SAM site, is lo-	
J	appeared to be the larger of the two new build-	cated at 53-58-45N 24-48-20E, 17 nm northwest	
	ings was actually two smaller ones, probably	of Lida.	
	still under construction. The function of the three		25X1
	new buildings cannot be determined at present.	by 80 feet were identified on photog-	25>
	The nearest SA-2 site with similar large	raphy ofand appeared unchanged in	
	revetments is Volkovysk A34-2, located 23 nm	(Figure 10). One is 500 feet north-	25>
	north. Collocated SA-3 site B19A-3 is 2,500 feet	northeast of the center of the site, the other 500	
		feet west-northwest of the site. Both revetments	
1	north-northwest.	are drive-through, but no through service road

site. Both appear to be drive-through, but no	The nearest SA-2 SAM site with similar	
	through roads servicing them can be identified.	large revetments is Volkovysk A34-2, located	
<b>;</b>	No change had taken place in either revetment	24 nm south-southwest. Collocated SA-3 Site	
	by by	C29A-3 is 2,000 feet north.	
	The state of the s	OZ/II O 16 2,000 feet her til.	
	25X1D

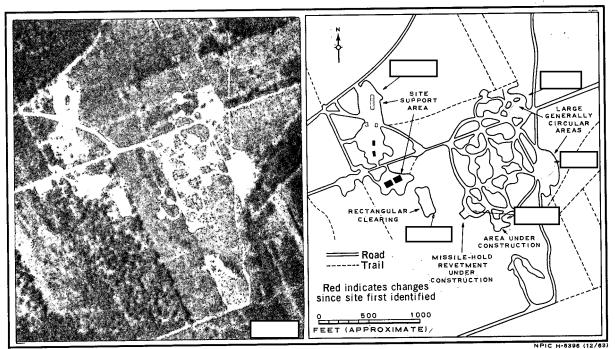
25X1D FIGURE 11. RIGA SAM SITE B03-2.

Riga Site B03-2 appeared complete on Riga SAM Site B03-2 photography of 25X1D , is 10 nm north-This site. northeast of Riga and is located at 57-05-40N 24-13-00E. buildings have been added there. hotography of \_\_\_\_\_, two ·On 25X1D large generally circular areas under construc-25X1 tion adjacent to this site were identified as similar to revetted areas at other SA-2 sites (Fig-25X1D ure 11). One area, feet, is 560 feet north-northeast of the center of the site, located where a small clearing had previously been obbeing enlarged in served. Construction appears to have started 25X1D observed in there in \_\_\_\_\_ The other area, 25X1D feet, is 630 feet east of the center of the site, located where a missile-hold revetment had been Construction was under construction in 25X1D noted in 25X1Dinderway there in [ termined at this time. Both areas are irregularly shaped, but generally circular, and 25X1D still appeared to be under construction in 25X1D

25X 25X that time there was a site support area. In there was additional construction underway 25X north of the original support area, and three Construction work was underway between 25X in two areas on the southern perimeter of the site, both areas being drivethrough. The more westerly of these areas is a missile-hold revetment which apparently was 25X and the other area is irregularly shaped, with construction newly 25X The function of a rectangular clearing between the launch site and the site support area, 25X cannot be de-

The nearest SA-2 site with large revetments is Lida C29-2, located 190 nm south. The nearest SA-3 site is Pavilosta C07A-3, 108 nm west.
